EXPANDED SITE INSPECTION REPORT
FOR

FAIRMONT RAILWAY MOTORS
FAIRMONT, MINNESOTA

U.S. EPA ID: MND096488986

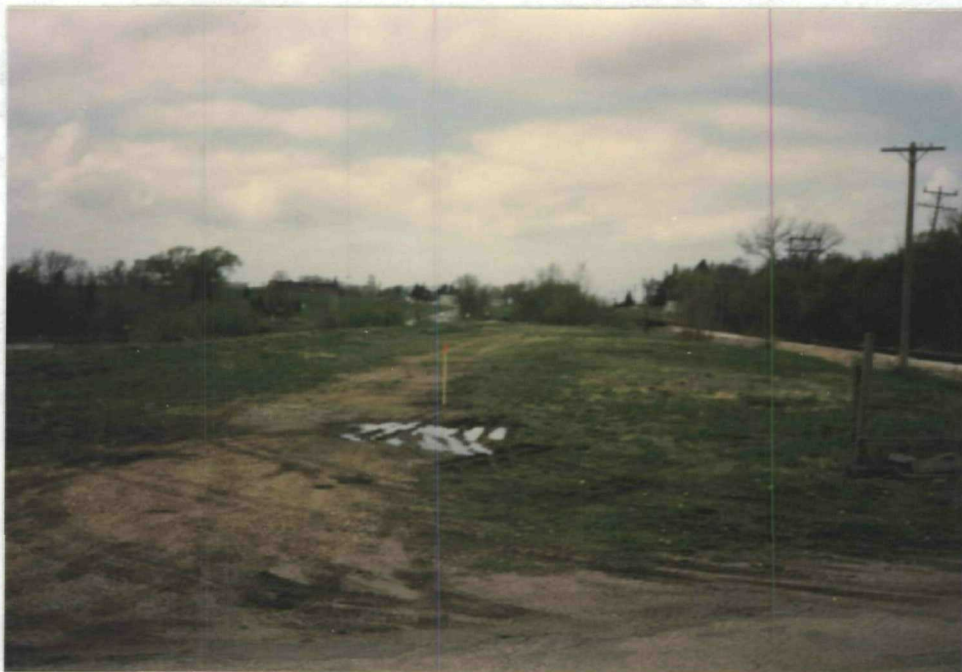
Description Boring locations

B-5 (foreground) + B-6

(background), west landfill
area

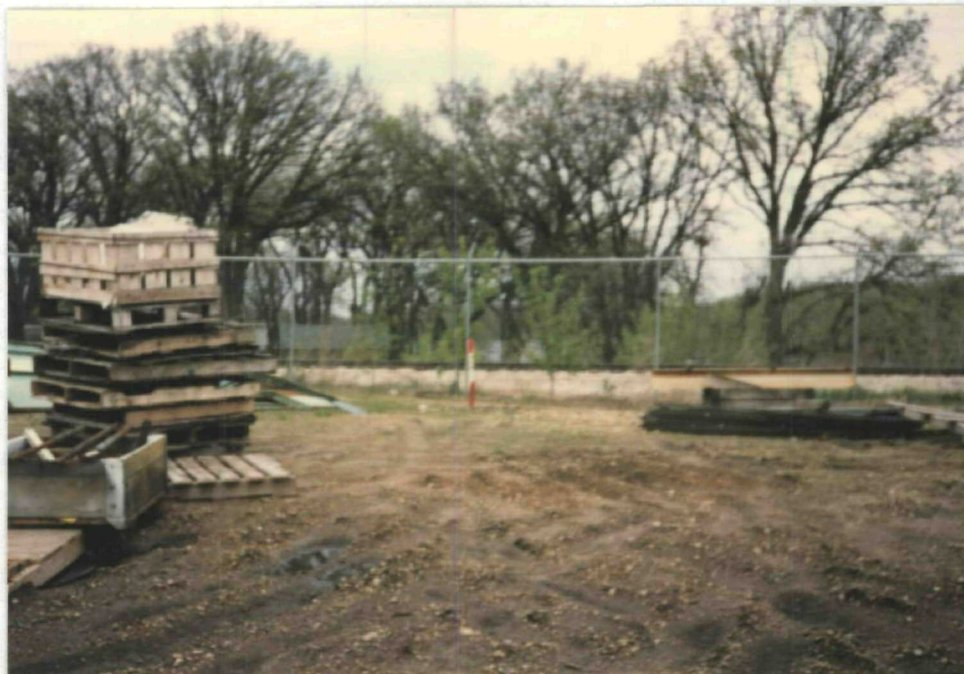
Description Boring location

B-6

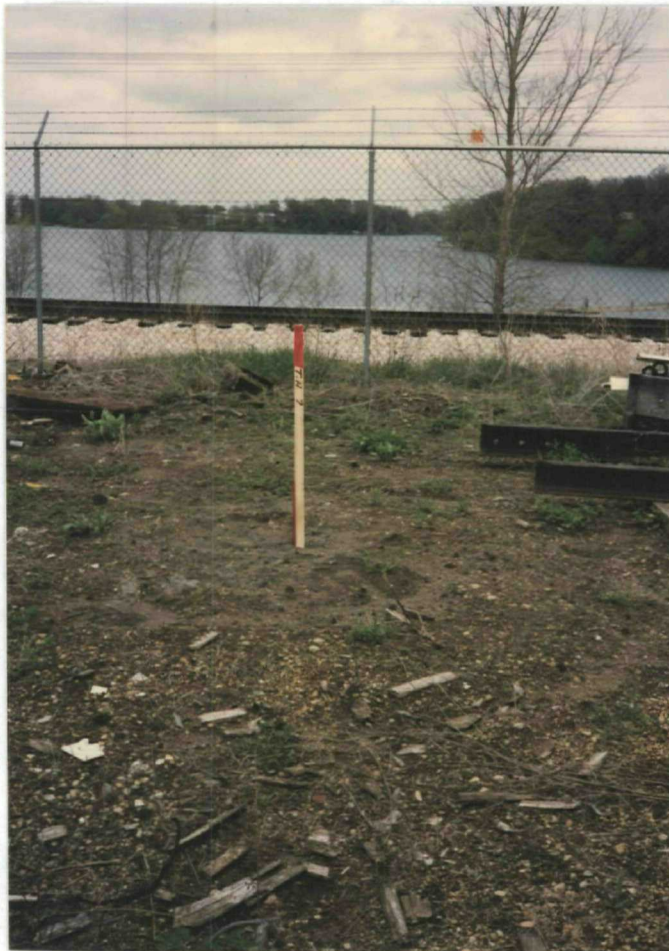
Description Location of

boring B-7
